**Plowshare**

# PROJECT PRE-SCHOONER II

## POSTSHOT GEOLOGIC AND ENGINEERING PROPERTIES INVESTIGATIONS

ALTON D. FRANDSEN

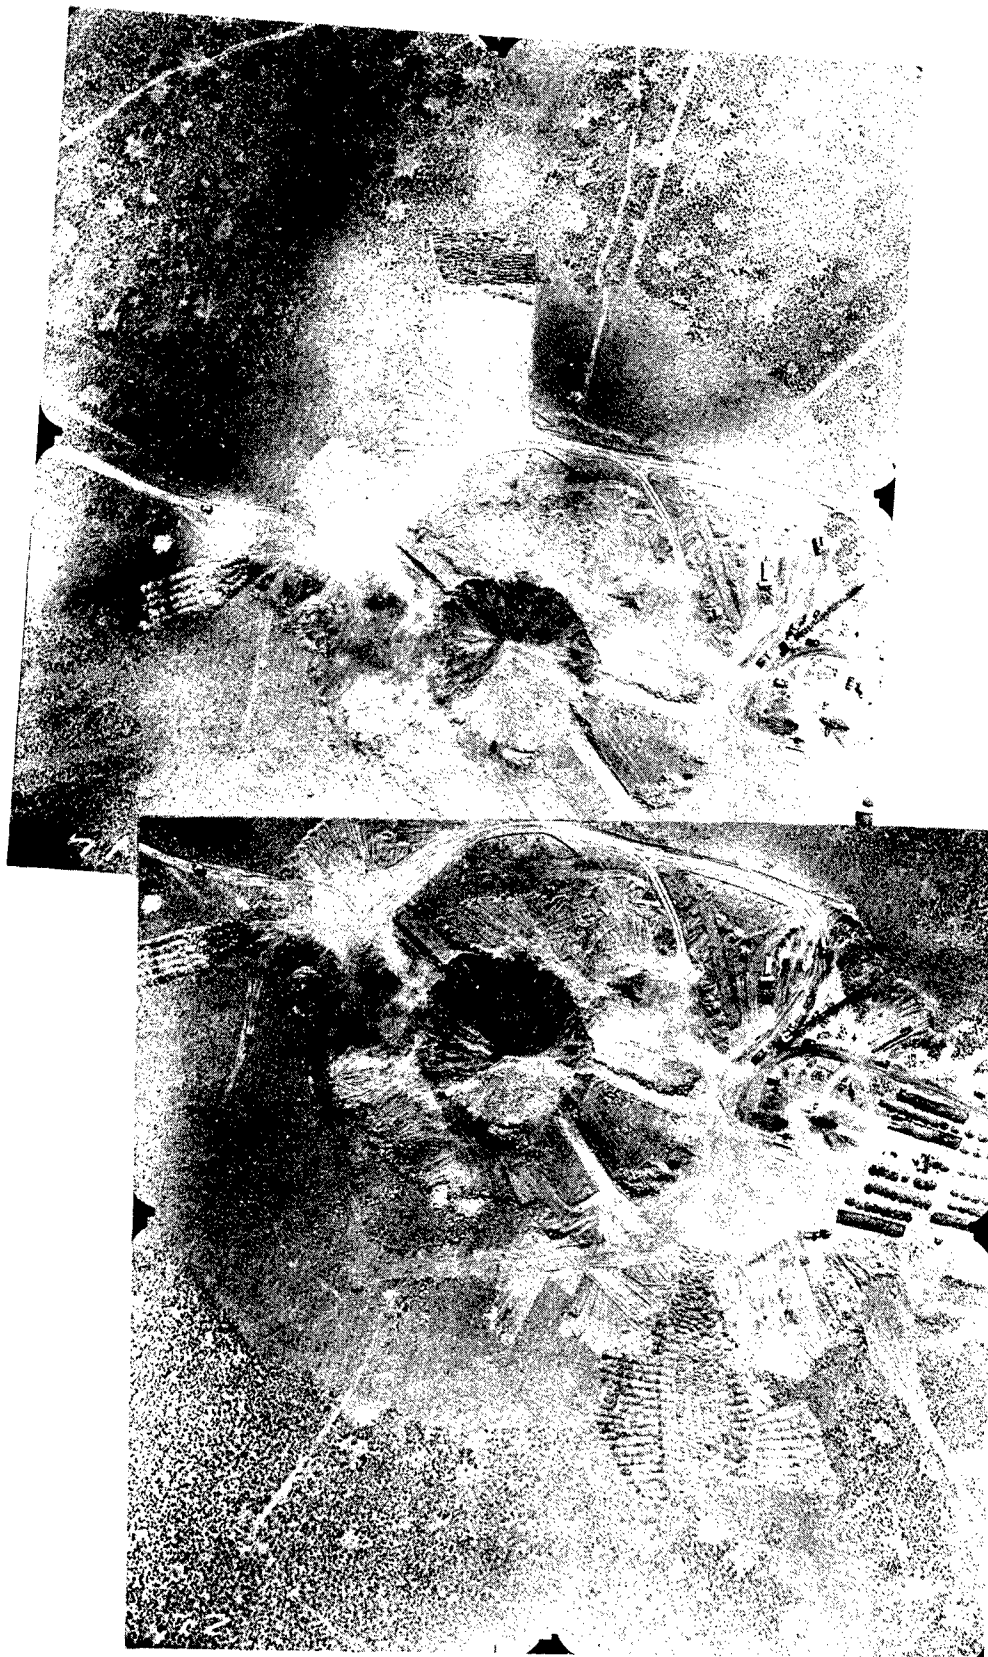
Figure 3.4 Aerial photo prior to excavation of fallback (photos paired for stereoscopic viewing).

possible. A final aerial photograph and map were made at the completion of all excavation. Photographic stereoscopic pairs of the excavation phases, and corresponding topographic maps, are shown in Figures 3.2 through 3.7.

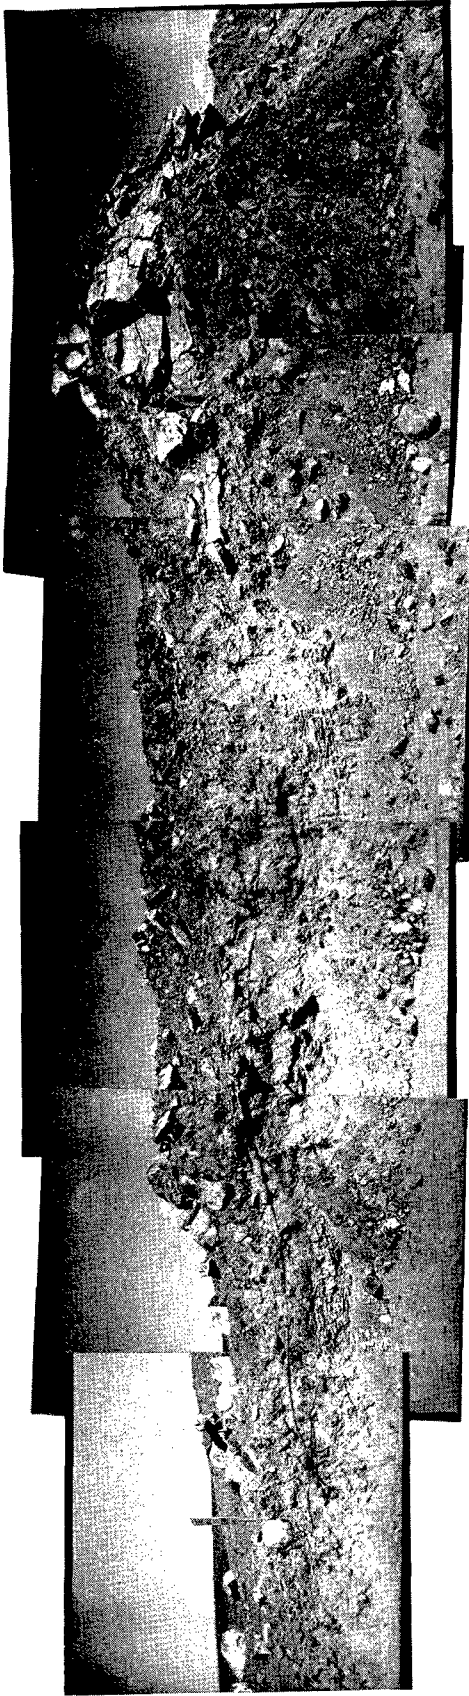
Figure 4.6 Ground profiles from Trench No. 1.

After the trenches were excavated, one wall of each trench was examined and mapped to delineate the true crater boundary and amount of uplift. The results of this mapping are shown in Figures 4.6 through 4.9 for Trenches No. 1, and No. 3. The true crater radius and amount of uplift are listed in Table 4.4.

From an examination of the trench profiles, it can be seen that in all three trenches the soil and caliche have been removed from above the uplifted bedrock for a distance of 8 to 24 feet back from the true crater zone. This condition is probably the result of surface spalling. In Trench No. 1 there has also been overthrusting of wedges of material which, prior to the detonation, constituted the ground surface closer to SGZ.

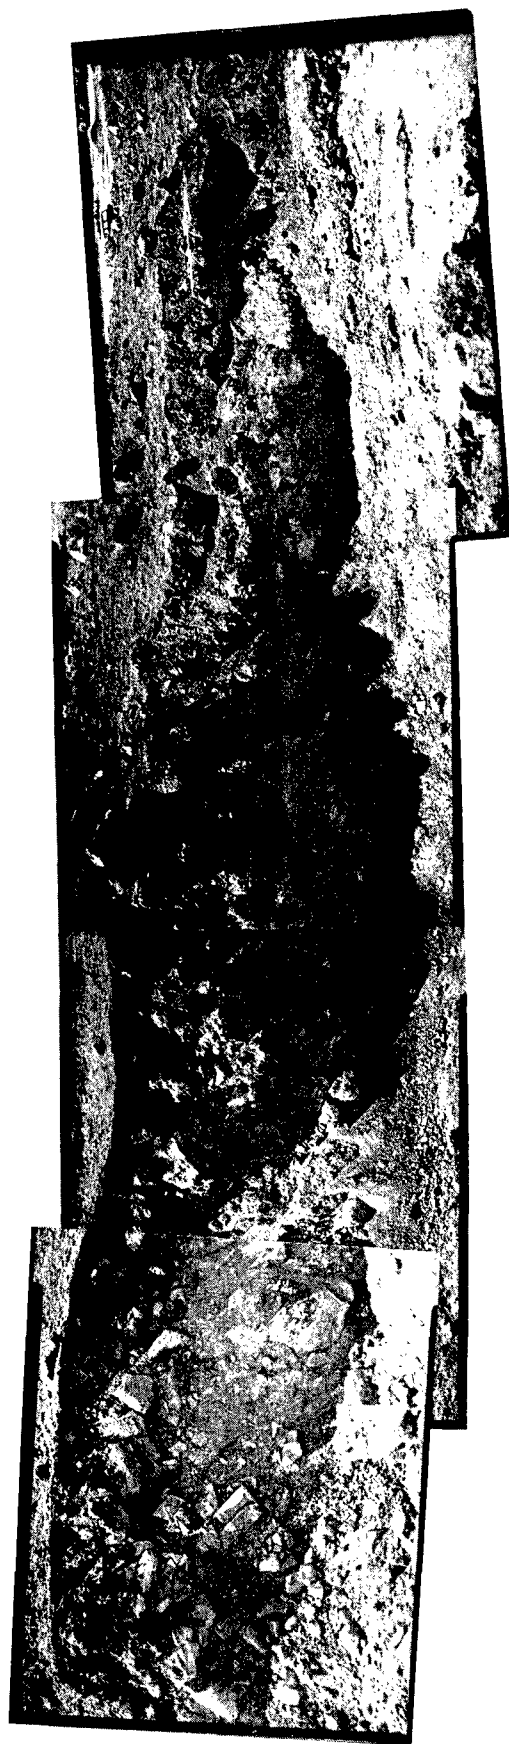
Figure 4.7 Ground profiles from Trench No. 2, west wall.

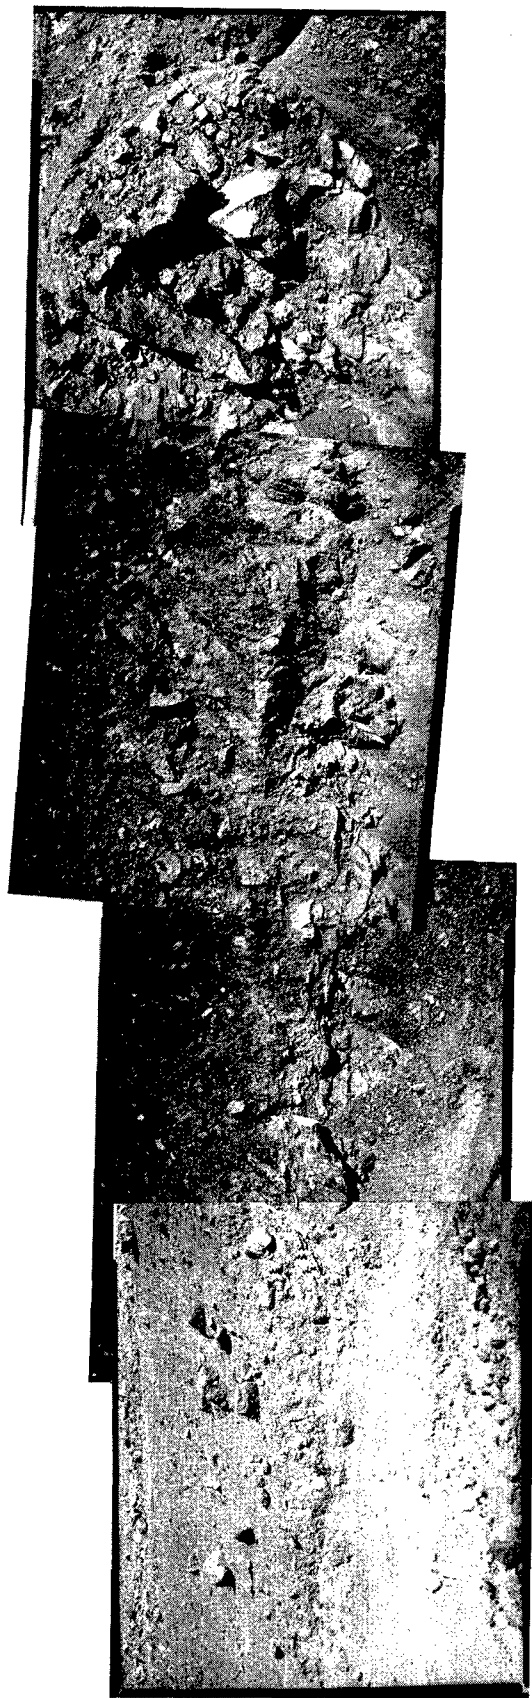
Figure 4.8 Ground profiles from Trench No. 2, east wall.

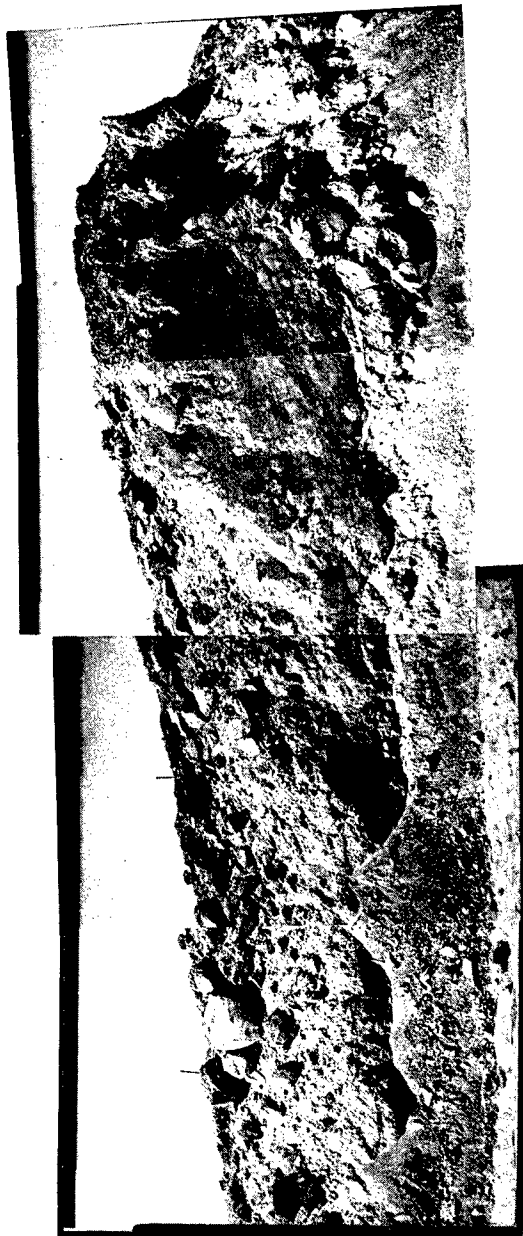
Figure 4.9 Ground profiles from Trench No. 3.
